**A HUMAN FACTORS ANALYSIS OF
HIGHWAY-RAILWAY GRADE CROSSING
ACCIDENTS IN CANADA**

Prepared by
Transportation Development Centre
Transport Canada

by
Cognitive Ergonomics Research Laboratory
Department of Psychology, University of Calgary

September 2002

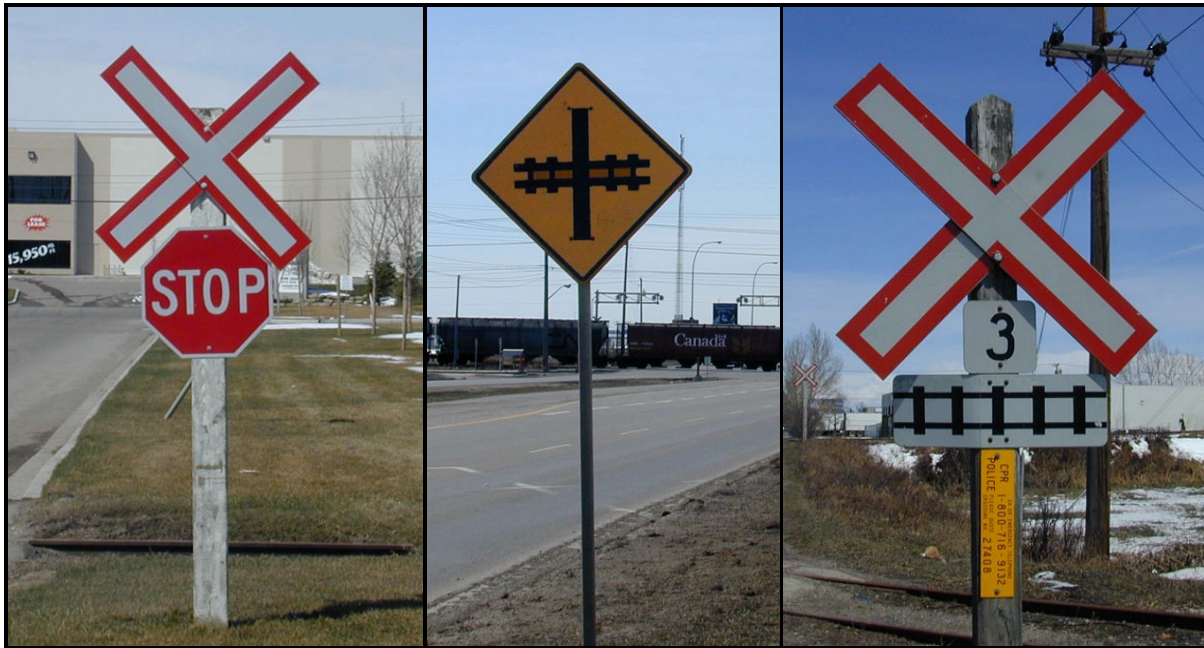
Figure 2.1 Advance Warning Signs: crossbuck (RA-6) with stop sign, advance warning sign, crossbuck with multiple track signage (RA-6s).

yellow background (e.g., see W18-20, MUTCDC). Variations of the sign indicate the location of the tracks relative to an intersection (see Figure 2.1). AWS's (WA-18R) depicting the railway track crossing the roadway at an angle are used at skew-angle crossings, since those configurations can present visibility problems. An advisory speed tab sign may also be placed below the AWS to indicate a recommended vehicle velocity when sight distances are limited.

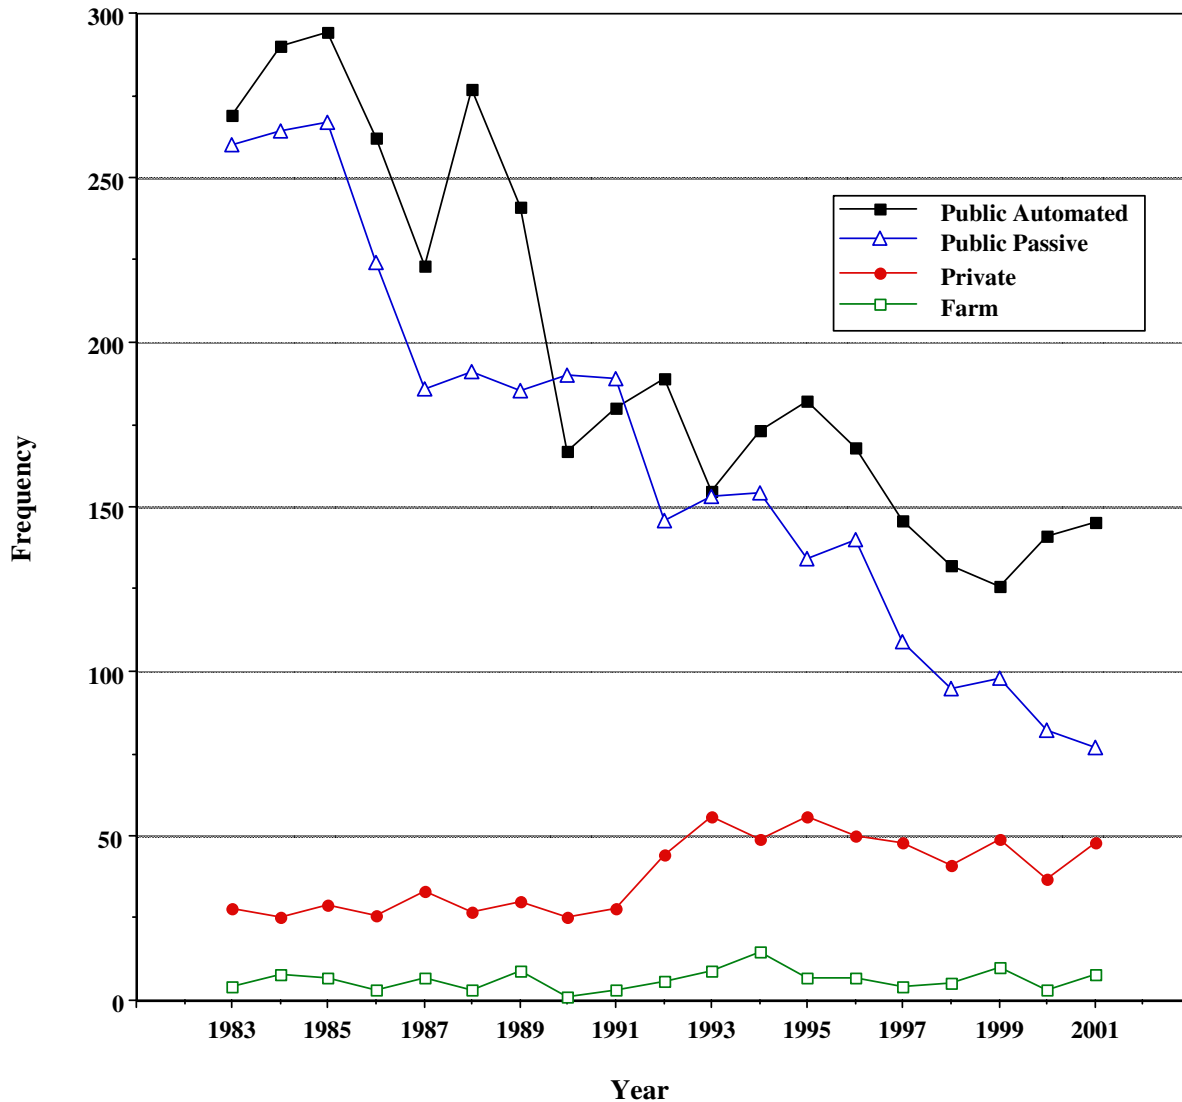
Figure 6.2 Accidents by crossing type per year from 1983 to 2001.

Like total accidents, public automated and public passive warning accidents have declined by approximately half over the past 19 years (see Figure 6.2). The increase in private crossing accidents in 1993 reflects changes in the reporting requirements. Prior to 1993, only private and farm crossing accidents were reported if they involved casualties (minor/serious injuries or fatalities) or a derailment resulting in property damage worth \$7,350 or more for main-track operations. As of 1993, all private and farm accidents must be reported.

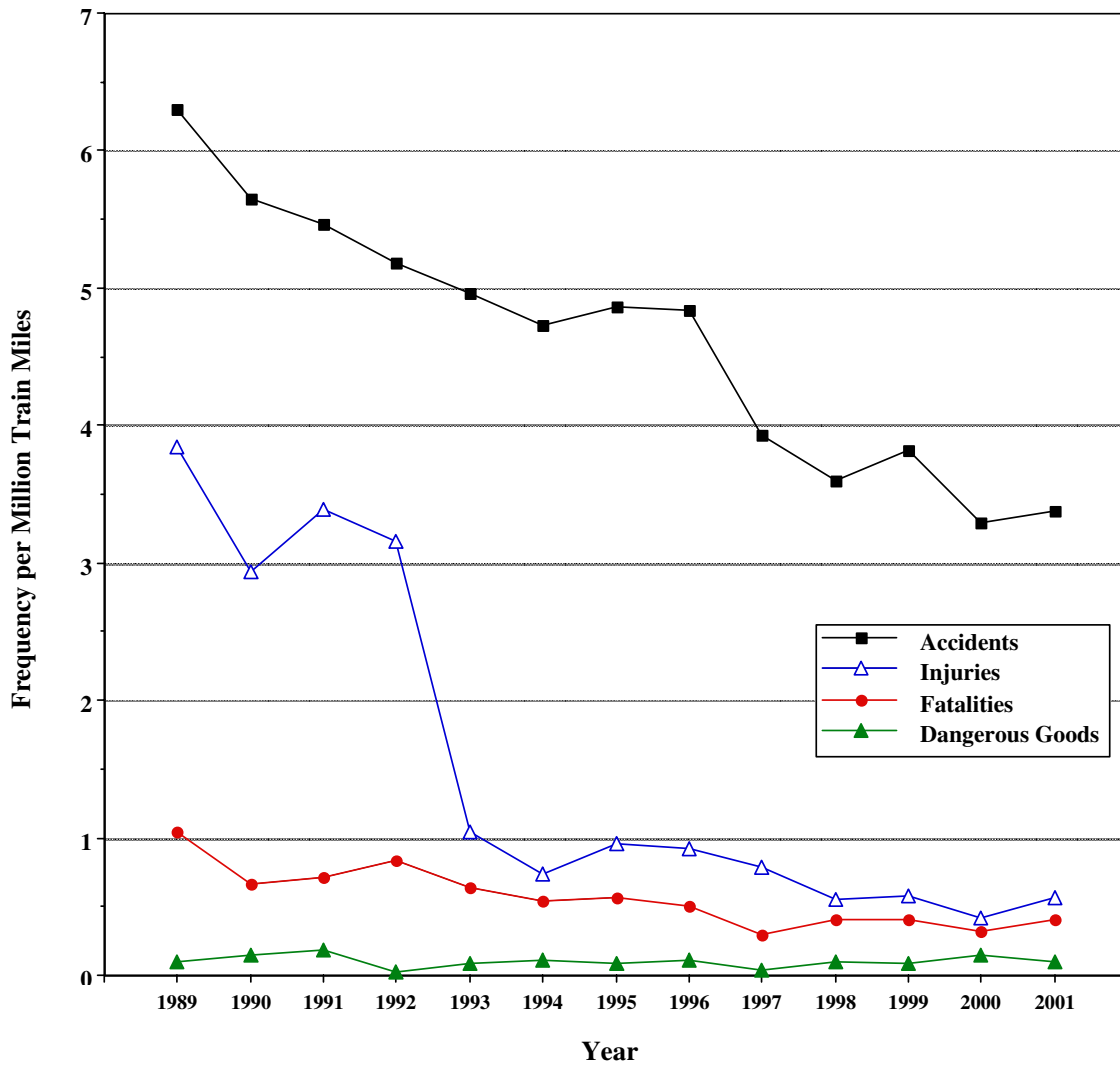
Figure 6.5 Accidents, injuries, fatalities, and dangerous goods per million train miles from 1989 to 2001.

Figures 6.5 and 6.6 illustrate accidents, injuries, fatalities, and dangerous goods expressed as frequency per million train miles (MTM) (6.5) and as a frequency (6.6). The dramatic drop in injuries between 1992 and 1993 is indicative of a change in classification criteria. The reporting criteria were changed by the TSB in 1993 from all injuries to just serious injuries. Accidents, injuries, and fatalities show declines from 1989 to 2001, while dangerous goods accidents remain constant.

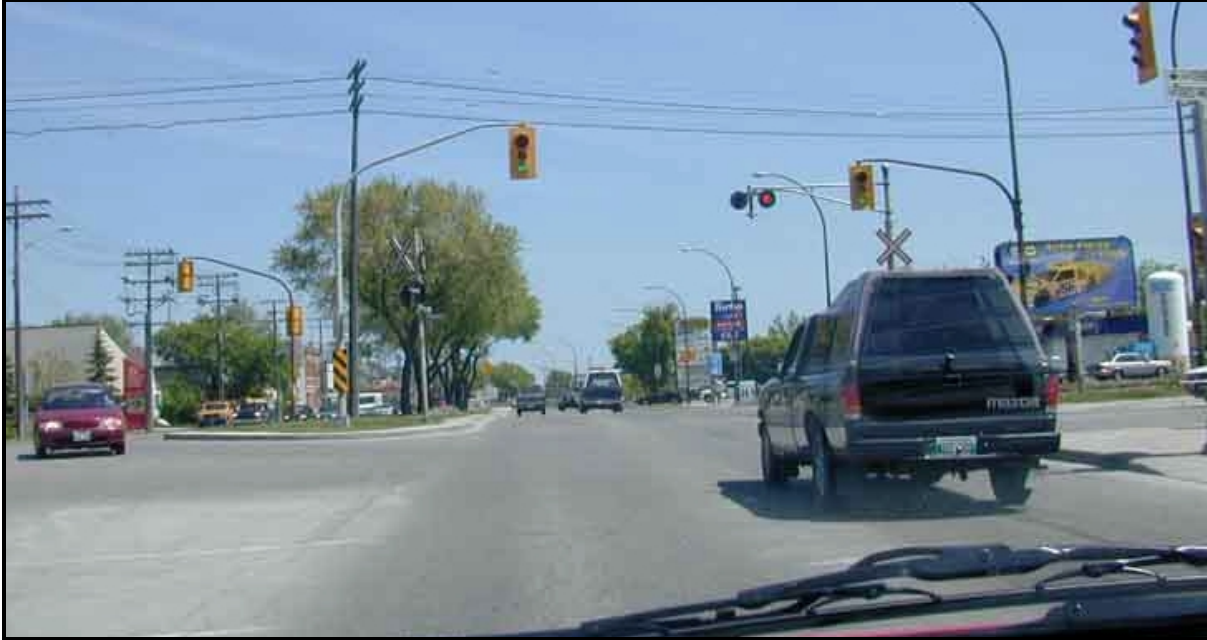
Figure 6.15 An intersection and a grade crossing in close proximity in urban Winnipeg. The visual demand of other vehicles, sign clutter, and signals make decisions to stop more difficult. The synchrony of the intersection lights (green) and crossing lights (flashing red) is not ideal. Interconnection of traffic lights and highway-railway grade crossing signals is suggested (Bremer & Ward, 1997).
